PALMER AIRPORT

2004 Alaska Airport Pavement Condition Report

PALMER MUNICIPAL AIRPORT - 2004

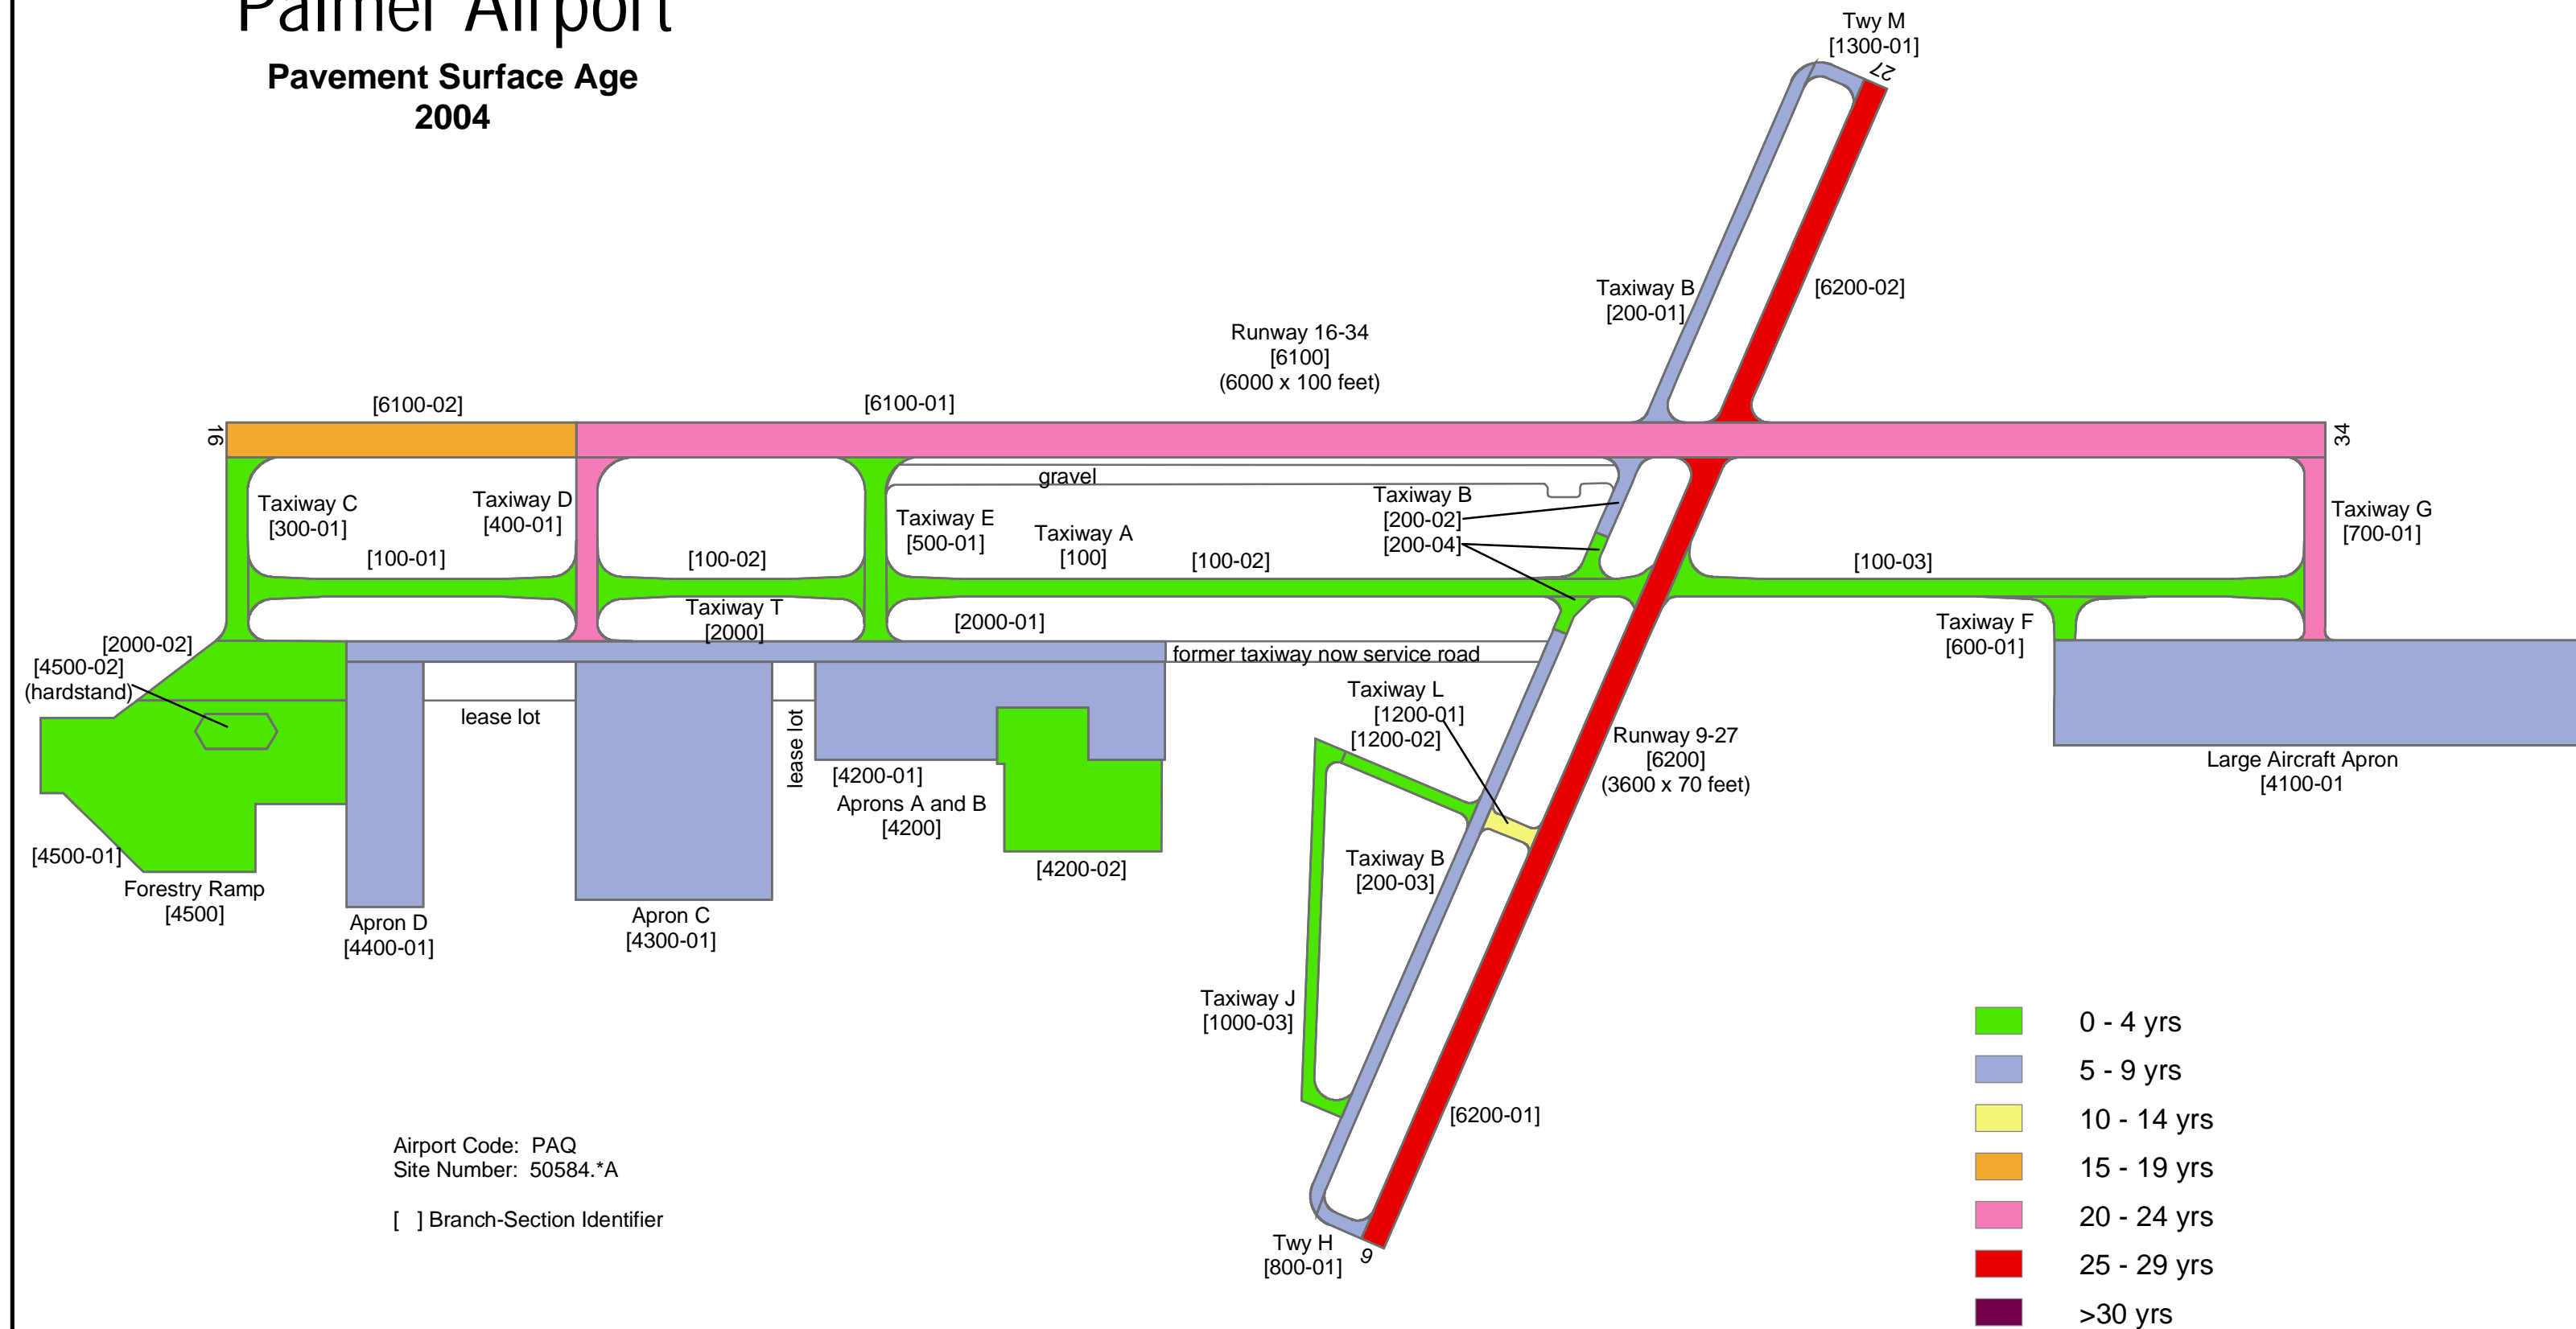
Pavement Condition Index (PCI) Measured Values for the Year 2004

- **Recommendations:** See PCI maps. Seal cracks that are greater than 1/4" wide and patch with hot mix or cold mix as required to maintain serviceability.
